NAVAL CIVIL ENGINEERING LABORATORY

ZINC INORGANIC SILICATE COATINGS: FIVE YEARS

MARINE ATMOSPHERIC EXPOSURE

Technical Report R-776

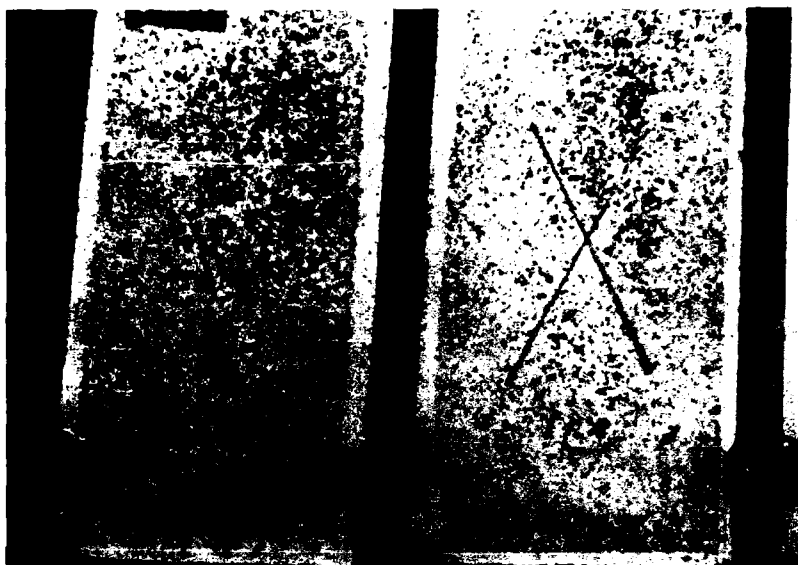
The manufacturer of the zinc inorganic silicate System 65 (self-cured) requested that the MIL-P-15328B wash primer not be used over this coating. The scribed panels of this system failed at Kwajalein during 18 months of exposure, at the Kaneohe Upper Site during 2 years, at the Kaneohe Lower Site during 4 years. After 5 years the scribed panel of System 65-0 was giving good protection at Port Hueneme Site 1. The unscribed panel of System 65-0 failed at Kwajalein during 4 years, but the oil-base coating is giving good to excellent protection to all panels at Port Hueneme and Kaneohe except for the scribed panel of System 62-0, which failed at Kaneohe after 4 years of exposure. At Kwajalein the scribed panels failed in 4 years for Systems 68-0 and 69-0 and in 3 years for System 62-0. The unscribed panel of System 62-0 was giving good protection after 5 years at Kwajalein. The unscribed panels failed at Kwajalein for System 68-0 in 5 years and for System 69-0 in 4 years. The failures were related to cracking and flaking of the topcoat system, and probably to the alkaline conditions originating at the zinc bulges beneath the topcoating (Figure 7).

Figure 7. System 68-0 (self-cured, with oil-base topcoat) exposed 5 years at Kwajalein. Note flaking of topcoat from zinc inorganic primer.

The specification oil-base coating, as expected, is not a satisfactory topcoat for zinc inorganic silicate coatings. This topcoat appeared to deteriorate and flake off of the surface of the zinc inorganic substrate. Although the zinc inorganic silicate primer coat continued to protect the steel test panel, the condition of the oil-base topcoat gave a poor appearance to the coated surface.
